Property Inspection Report

Property address: 678 Via Alhambra Unit B
Laguna Woods CA 92637-4532

Inspection date: Friday, August 10, 2018

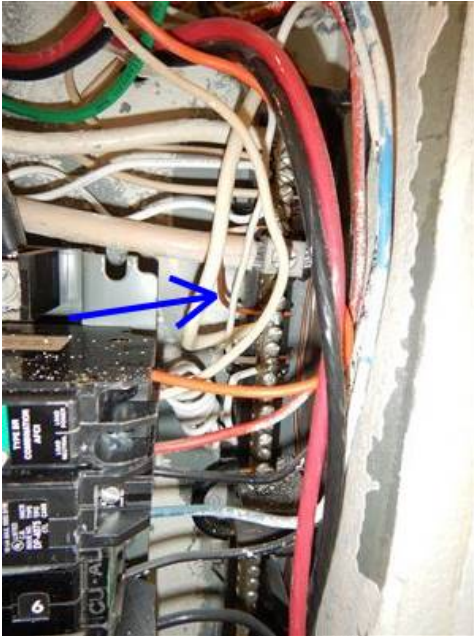
Photo 3-1 GROUND IN NEUTRAL BUS BAR

Neutral and equipment ground wires were bonded (connected) at the sub-panel. This should only occur in the main service panel, not sub-panels, and is a shock hazard. Neutral wires should be attached to a "floating" neutral bar not bonded to the panel, and grounding wires should be attached to a separate grounding bar bonded to the sub-panel. Recommend that a qualified electrician repair per standard building practices. For more information, visit: <http://www.reporthost.com/?SUBGRND>

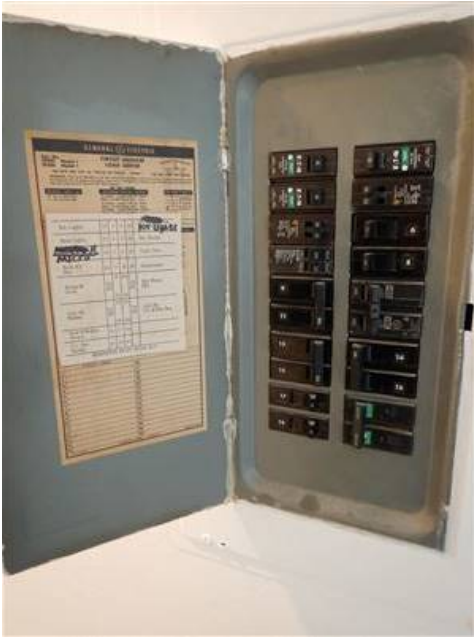
Photo 4-1

The legend for circuit breakers or fuses in panel(s) #B was incomplete and confusing. This is a potential shock or fire hazard in the event of an emergency when power needs to be turned off. Recommend correcting the legend so it's accurate, complete and legible. Evaluation by a qualified electrician may be necessary.

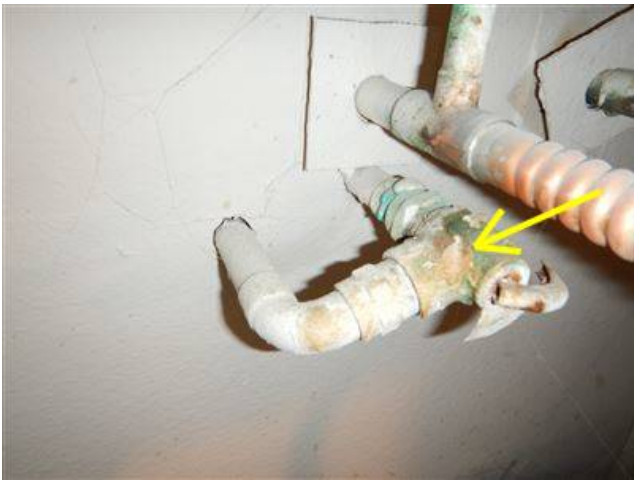
Photo 6-1 LOCATED ABOVE THE WATER HEATER

Significant corrosion was found in some water supply pipes or fittings. Leaks can occur as a result. Recommend that a qualified plumber evaluate and replace components as necessary.

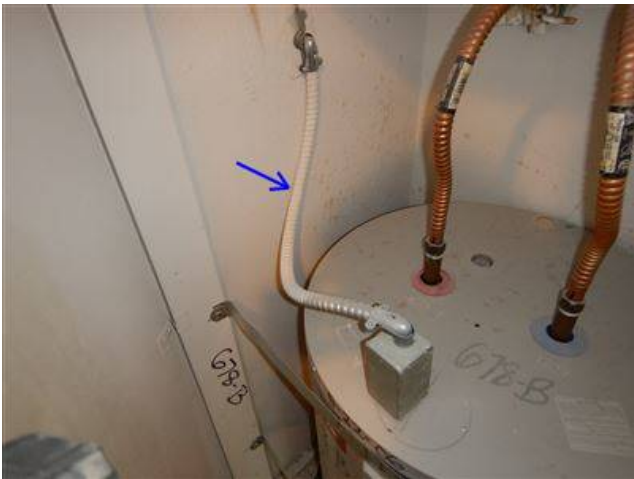
Photo 7-1

Wiring for the water heater's power supply was substandard, with loose conduit. This is a potential safety hazard for shock or fire. Recommend that a qualified person repair per standard building practices.

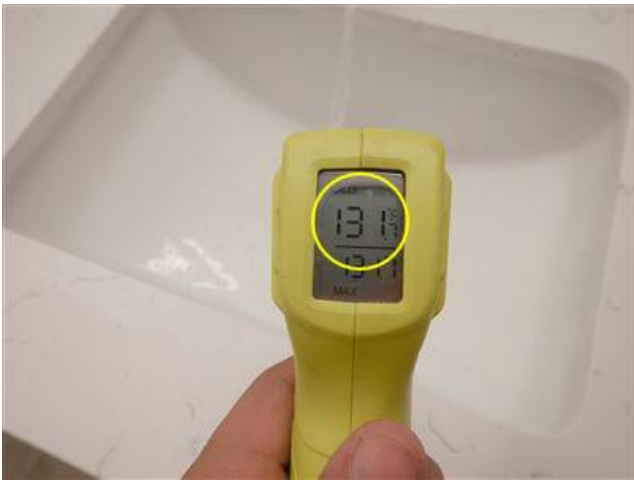
Photo 8-1

The hot water temperature was greater than 120 degrees Fahrenheit. This is a safety hazard due to the risk of scalding. The thermostat should be adjusted so the water temperature doesn't exceed 120 degrees. If the water heater is powered by electricity, a qualified person should perform the adjustment, since covers that expose energized equipment normally need to be removed. For more information on scalding dangers, visit: <http://www.reporhost.com/?SCALD>

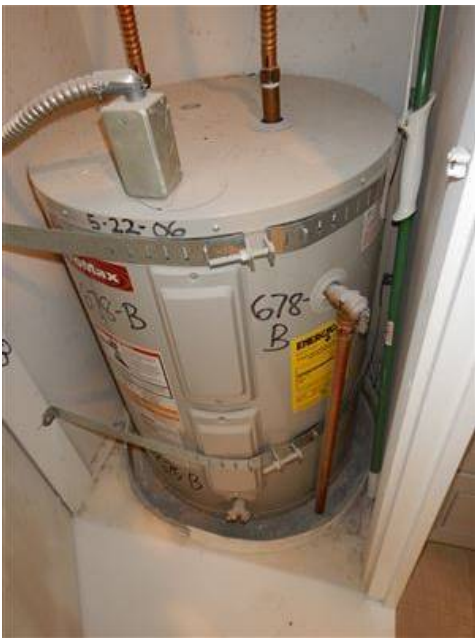
Photo 9-1

- 9) ✓ The water heater was in good working condition.

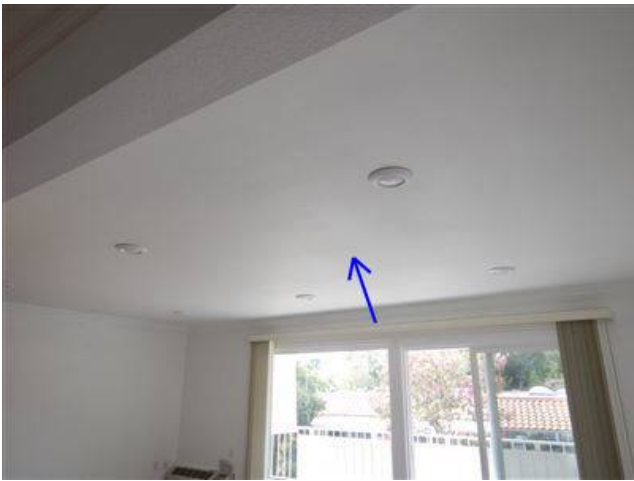
Photo 10-1 LIVING ROOM

- 10) 🔧🔍 Electric in-ceiling radiant heating appeared to be inoperable in the living room. Only a limited evaluation was performed because the heating elements are hidden and inaccessible. Recommend that a qualified specialist evaluate and repair as necessary.

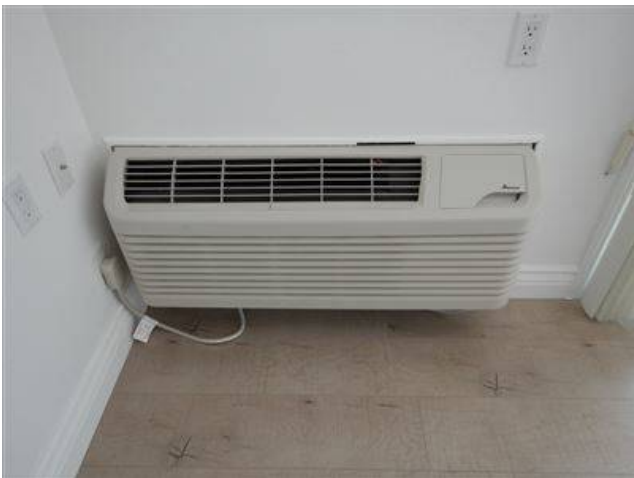
Photo 11-1

11) ✓ The through-wall heating & cooling unit was in good working condition.

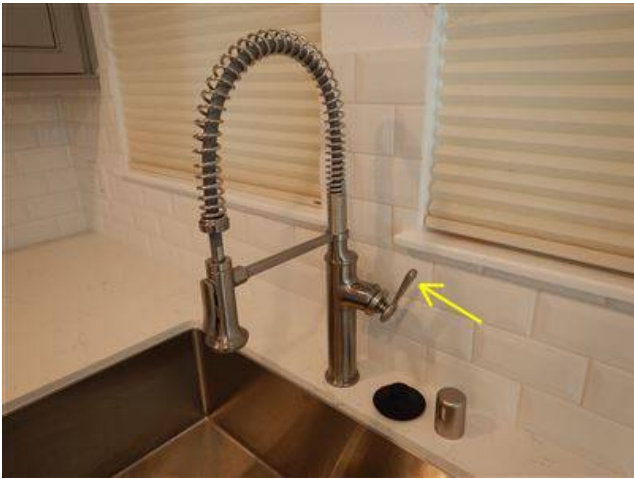
Photo 13-1

13) The flow from the sink's cold water supply was inoperable. Recommend that a qualified person evaluate and repair as necessary. Shut-off valves may be partially or fully closed. Note that the inspector does not operate shut-off valves. If repairs are needed, a qualified plumber should make them.

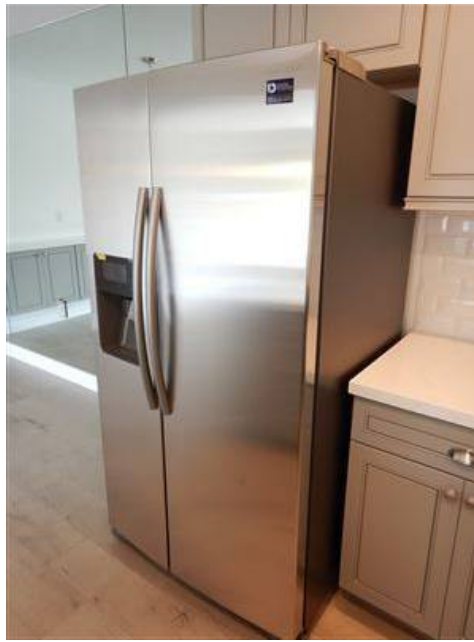
Photo 14-2

14) Water was found below the freezer's door. Recommend that a qualified specialist evaluate and repair if necessary.

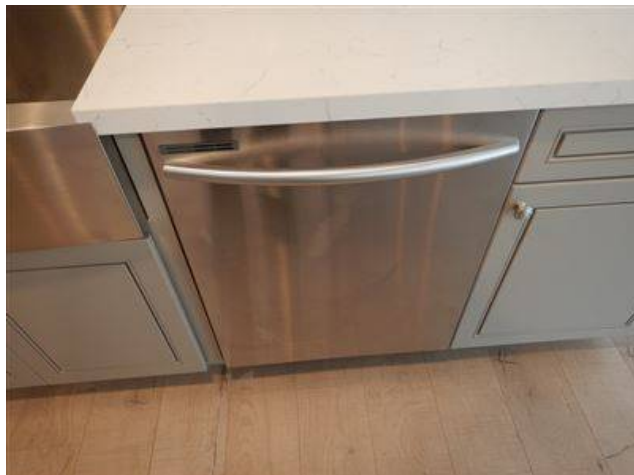
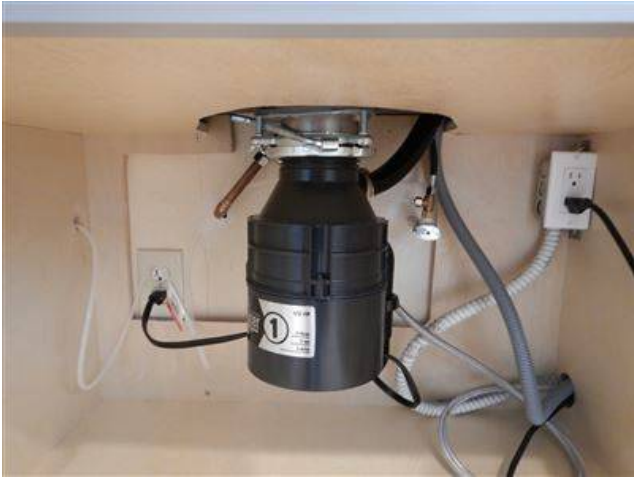
15) ✓ The microwave, dishwasher and food disposal were in good working condition.

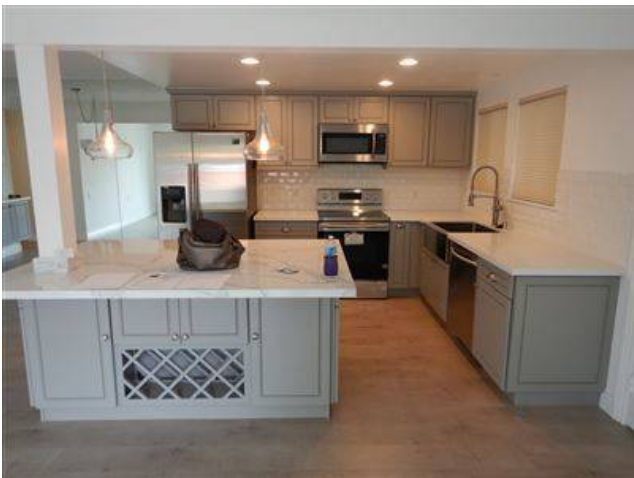
Photo 16-1

The kitchen appeared to be in overall good condition.

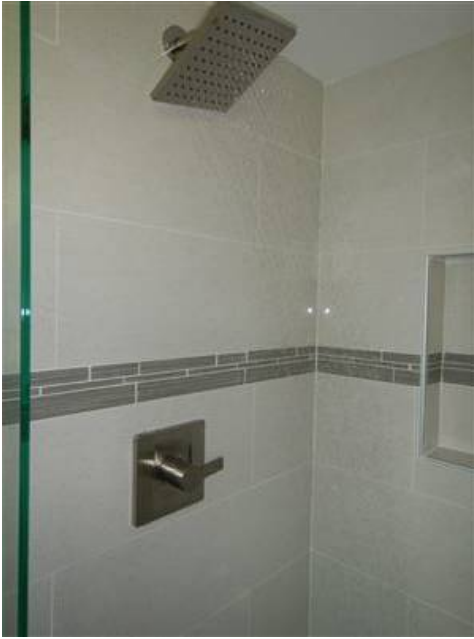
Photo 17-1

Water "hammering" occurred when the shower handle at location(s) #A was set to "Hot". Vibrations and a loud pulsating noise is heard. Recommend that a qualified plumber evaluate and repair as necessary.

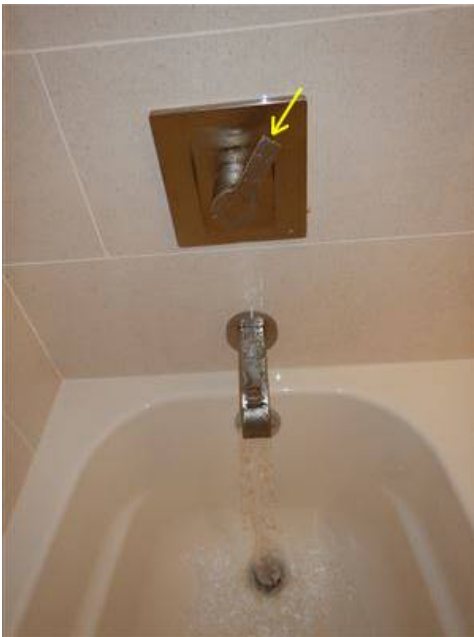
Photo 18-1

18) 🛠️ The hot and cold water supplies appeared to be reversed at the bathtub at location(s) #B. Normally, cold water is controlled by the right faucet handle and hot by the left. For mixing faucets, cold is supplied with the handle to the right and hot when the handle is to the left, or as indicated by the faucet's markings. At a minimum this is an inconvenience, but it can also result in accidental scalding. Recommend that a qualified plumber repair as necessary.

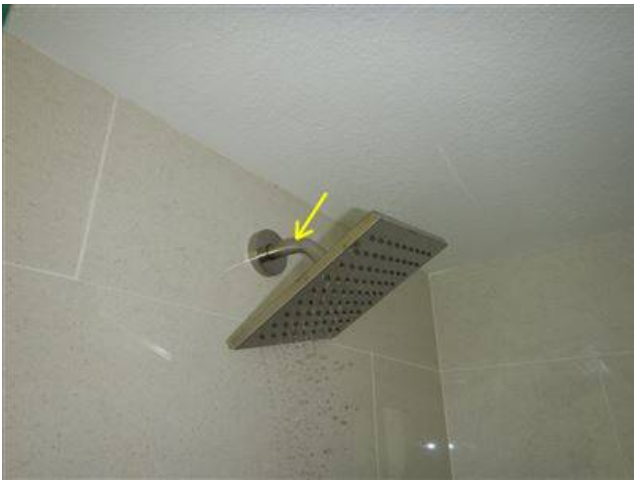
Photo 19-1

19) 🛠️ The shower arm at location(s) #A was loose. Recommend that a qualified person repair as necessary.

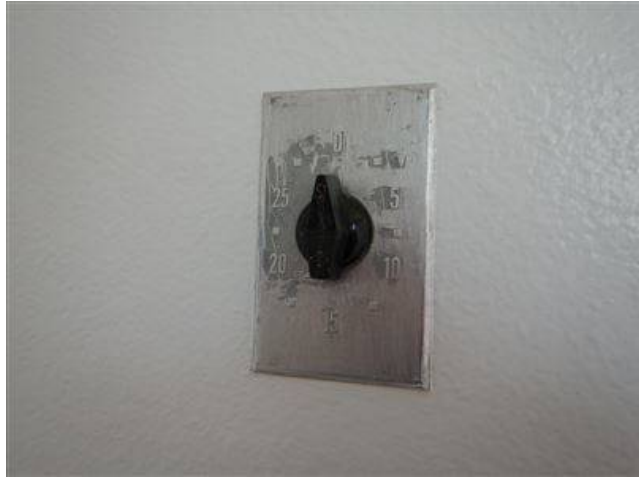
Photo 21-2

21) **i** The exhaust fan at location(s) #A was not operable. Only the fan's heater operated when the knob was turned. No switch found to operate the exhaust fan only. Recommend consulting with the property owner about this.

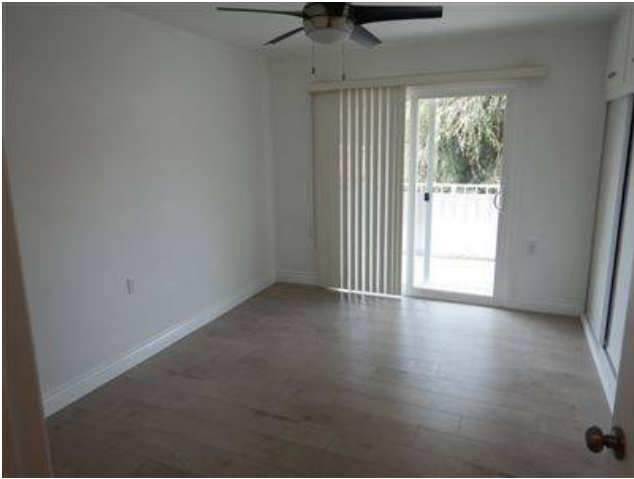
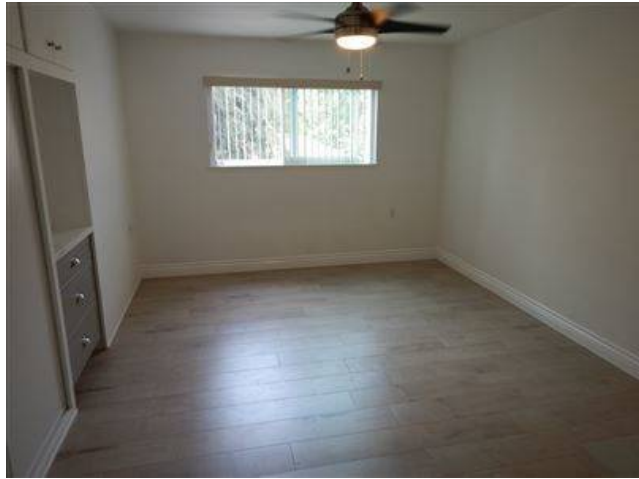
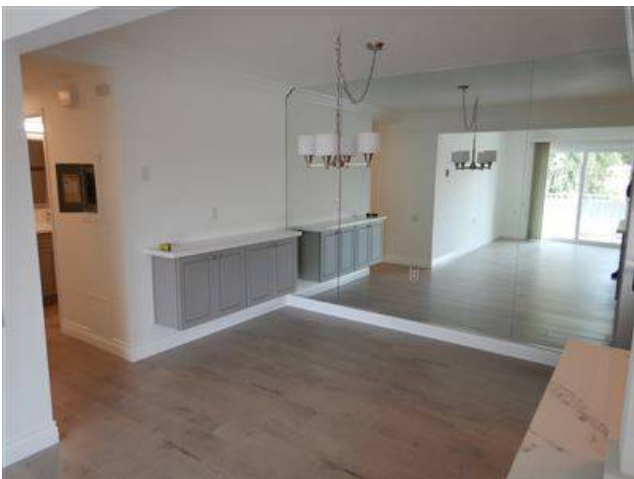
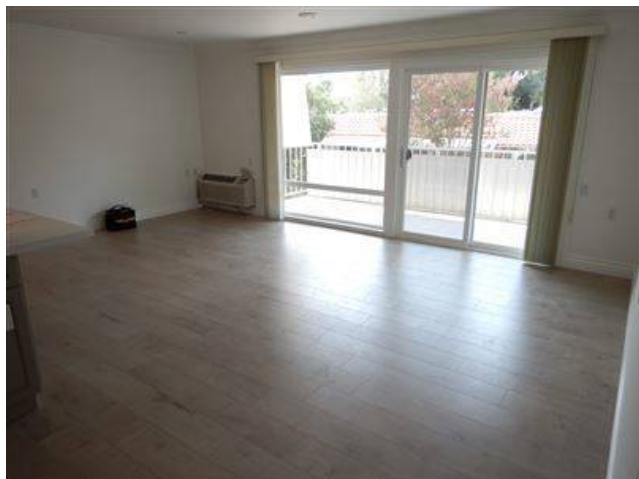
The interior rooms appeared to be in overall good condition.

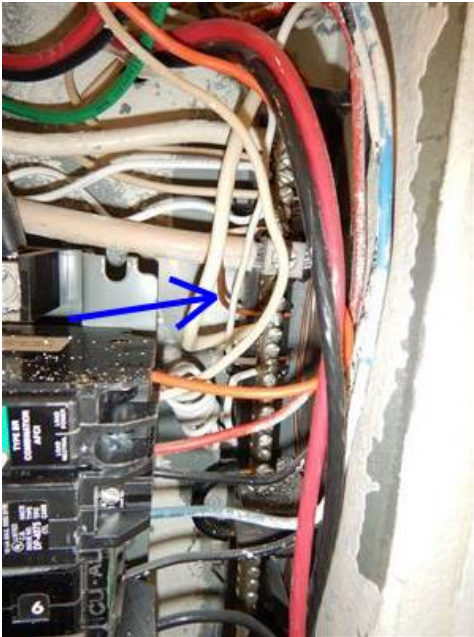
Photo 3-1 GROUND IN NEUTRAL BUS BAR

Neutral and equipment ground wires were bonded (connected) at the sub-panel. This should only occur in the main service panel, not sub-panels, and is a shock hazard. Neutral wires should be attached to a "floating" neutral bar not bonded to the panel, and grounding wires should be attached to a separate grounding bar bonded to the sub-panel. Recommend that a qualified electrician repair per standard building practices. For more information, visit: <http://www.reporthost.com/?SUBGRND>

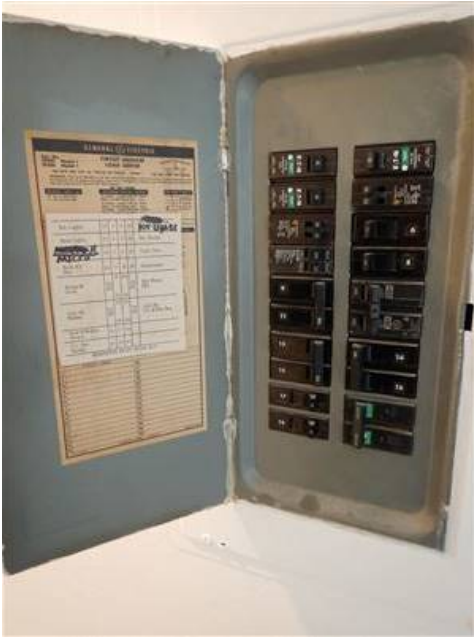
Photo 4-1

The legend for circuit breakers or fuses in panel(s) #B was incomplete and confusing. This is a potential shock or fire hazard in the event of an emergency when power needs to be turned off. Recommend correcting the legend so it's accurate, complete and legible. Evaluation by a qualified electrician may be necessary.

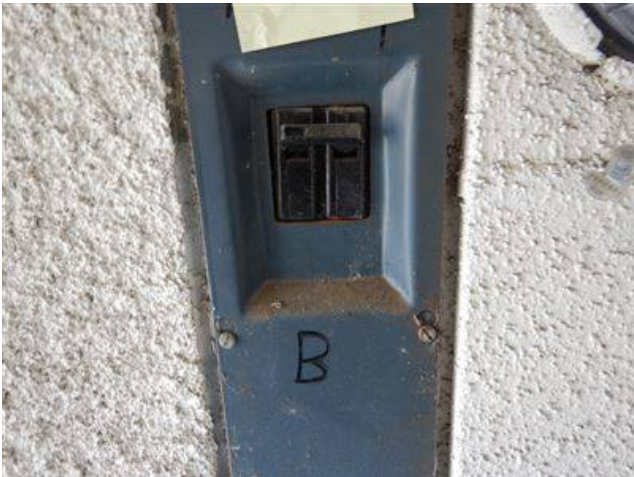
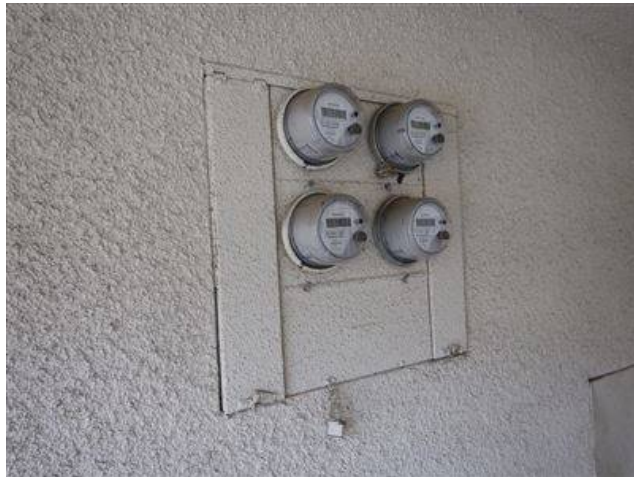
Photo 5-2 NEXT TO THE CRAWL SPACE ACCESS POINT

- 5) **i** The main service panel and main breaker are located at the exterior.

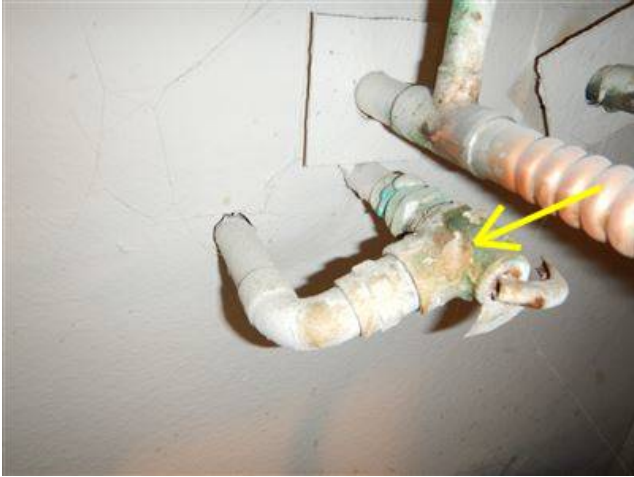
Photo 6-1 LOCATED ABOVE THE WATER HEATER

Significant corrosion was found in some water supply pipes or fittings. Leaks can occur as a result. Recommend that a qualified plumber evaluate and replace components as necessary.

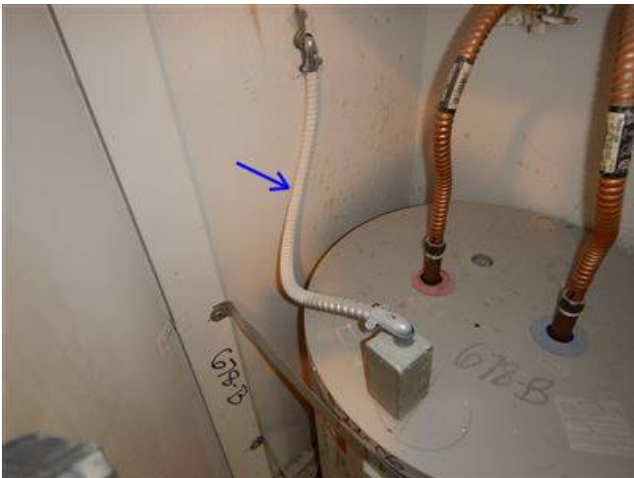
Photo 7-1

Wiring for the water heater's power supply was substandard, with loose conduit. This is a potential safety hazard for shock or fire. Recommend that a qualified person repair per standard building practices.

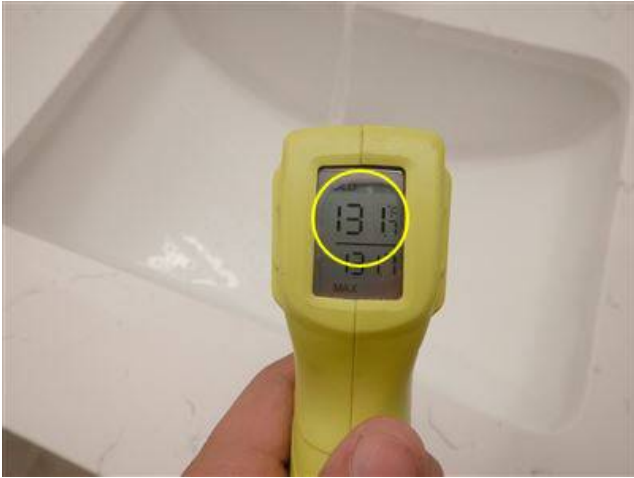
Photo 8-1

The hot water temperature was greater than 120 degrees Fahrenheit. This is a safety hazard due to the risk of scalding. The thermostat should be adjusted so the water temperature doesn't exceed 120 degrees. If the water heater is powered by electricity, a qualified person should perform the adjustment, since covers that expose energized equipment normally need to be removed. For

more information on scalding dangers, visit:
<http://www.reporthost.com/?SCALD>

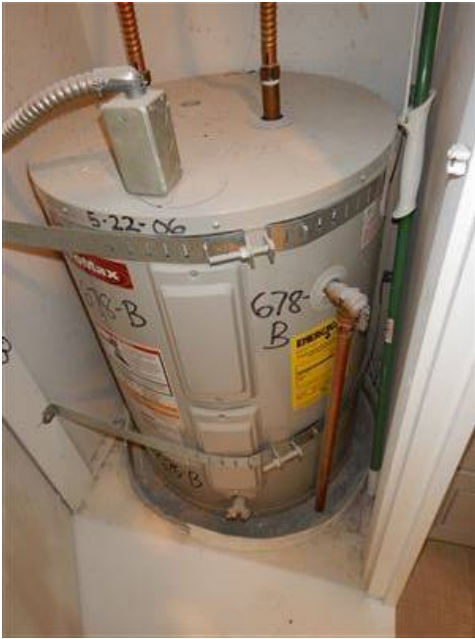
Photo 9-1

9) ✓ The water heater was in good working condition.

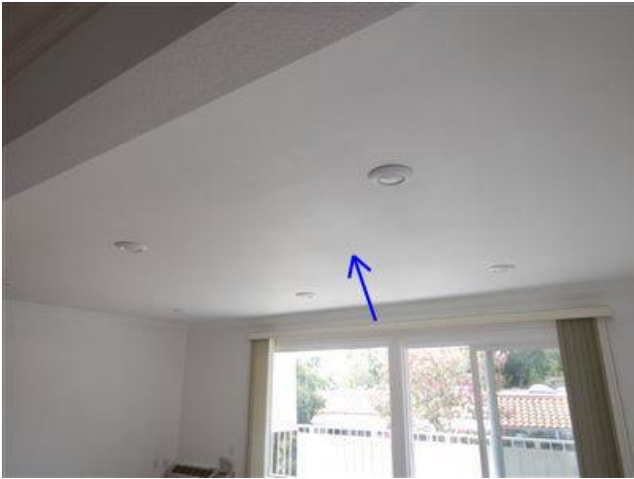
Photo 10-1 LIVING ROOM

- 10) 🔧🔍 Electric in-ceiling radiant heating appeared to be inoperable in the living room. Only a limited evaluation was performed because the heating elements are hidden and inaccessible. Recommend that a qualified specialist evaluate and repair as necessary.

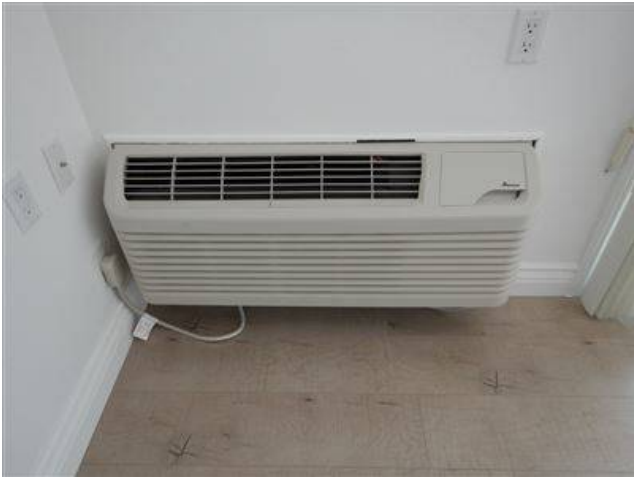
Photo 11-1

- 11) ✓ The through-wall heating & cooling unit was in good working condition.

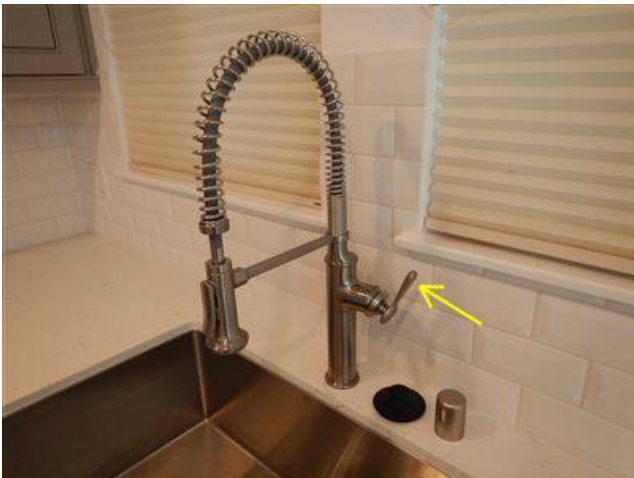
Photo 13-1

13) The flow from the sink's cold water supply was inoperable. Recommend that a qualified person evaluate and repair as necessary. Shut-off valves may be partially or fully closed. Note that the inspector does not operate shut-off valves. If repairs are needed, a qualified plumber should make them.

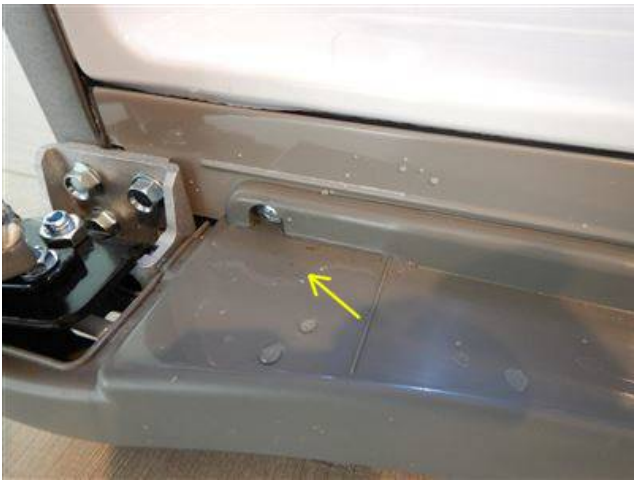
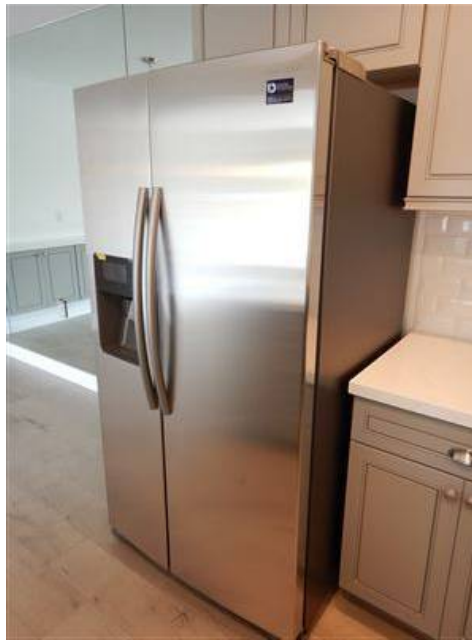
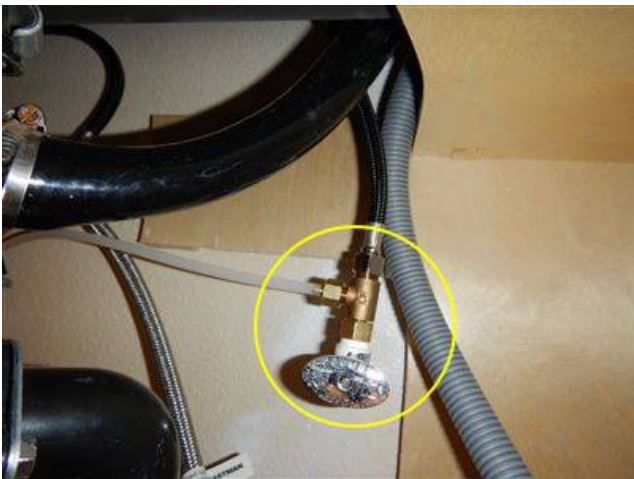
Photo 14-1

14) Water was found below the freezer's door. Recommend that a qualified specialist evaluate and repair if necessary.

The water supply for the refrigerator was inoperable (e.g. turned off, not plugged in) and the inspector was unable to fully evaluate.

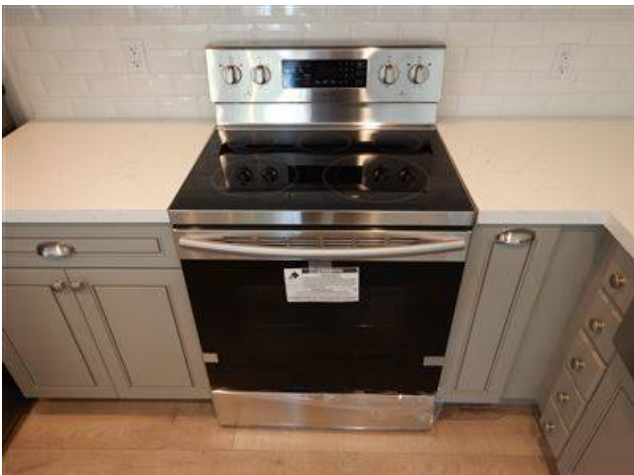
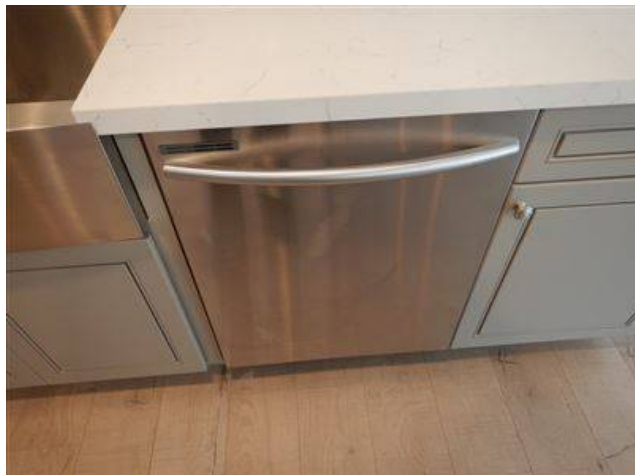
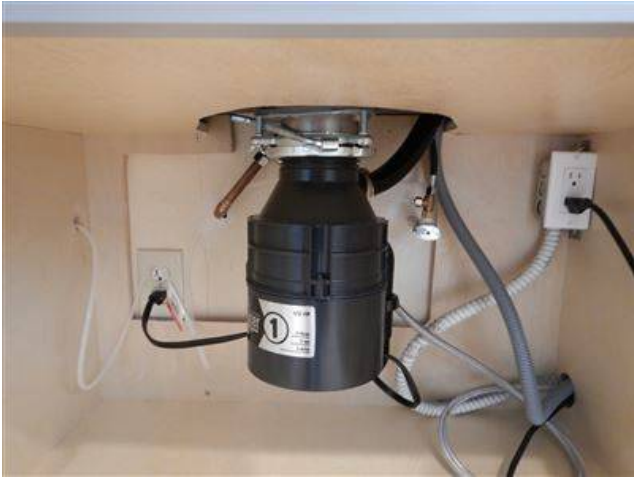
Photo 15-1

15) ✓ The microwave, dishwasher and food disposal were in good working condition.

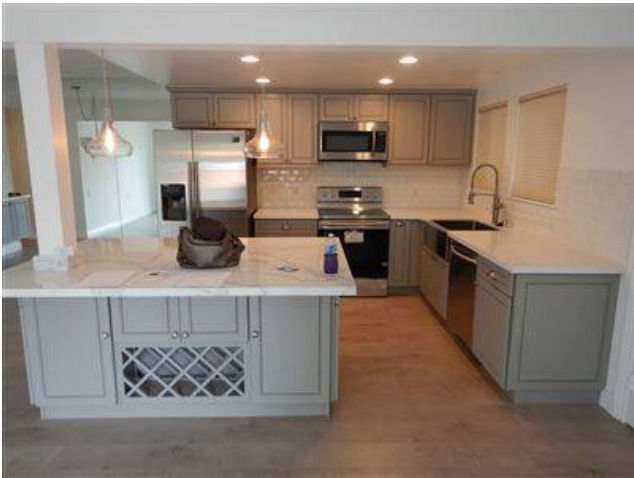
Photo 16-1

The kitchen appeared to be in overall good condition.

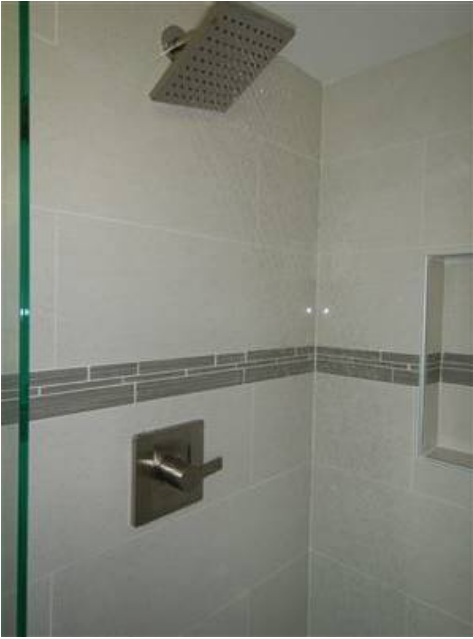
Photo 17-1

Water "hammering" occurred when the shower handle at location(s) #A was set to "Hot". Vibrations and a loud pulsating noise is heard. Recommend that a qualified plumber evaluate and repair as necessary.

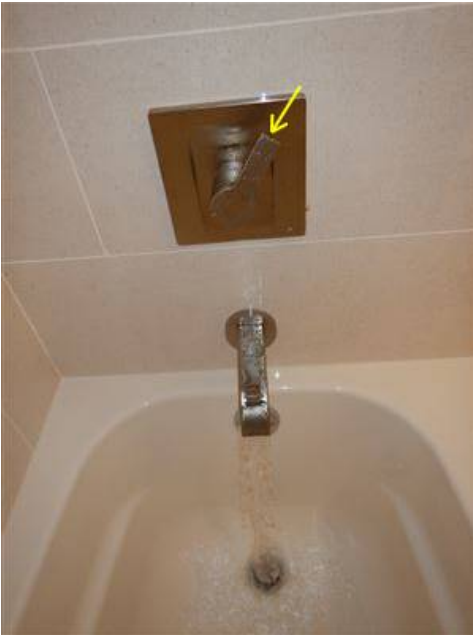
Photo 18-1

18) 🛠️ The hot and cold water supplies appeared to be reversed at the bathtub at location(s) #B. Normally, cold water is controlled by the right faucet handle and hot by the left. For mixing faucets, cold is supplied with the handle to the right and hot when the handle is to the left, or as indicated by the faucet's markings. At a minimum this is an inconvenience, but it can also result in accidental scalding. Recommend that a qualified plumber repair as necessary.

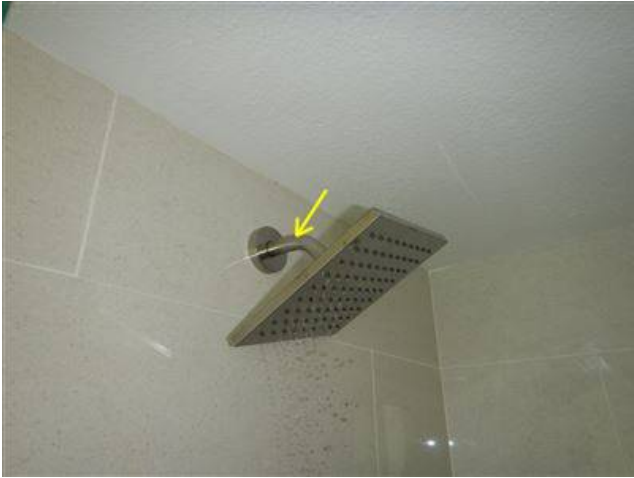
Photo 19-1

19) 🛠️ The shower arm at location(s) #A was loose. Recommend that a qualified person repair as necessary.

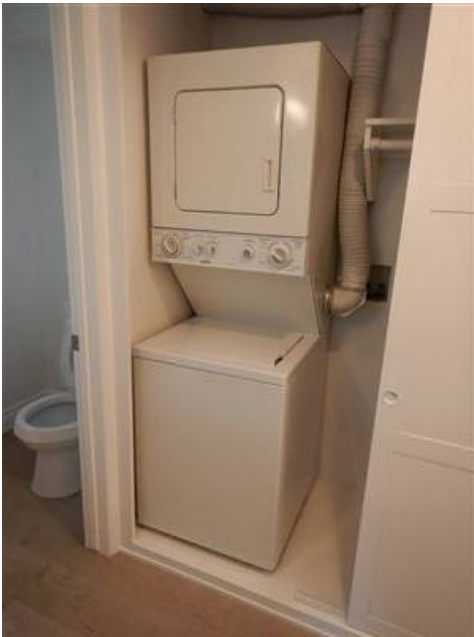
Photo 20-1

20) **i** No access or only limited access was available to the back of the clothes washer and dryer, and to utility hook-ups located behind the appliances. The inspector normally attempts to determine the presence of a gas vs. electric power supply, the configuration of the stand pipe, whether the dryer exhaust duct is serviceable, etc. Because of the lack of access, the inspector was unable to fully evaluate and/or describe the hook-ups and appliances.

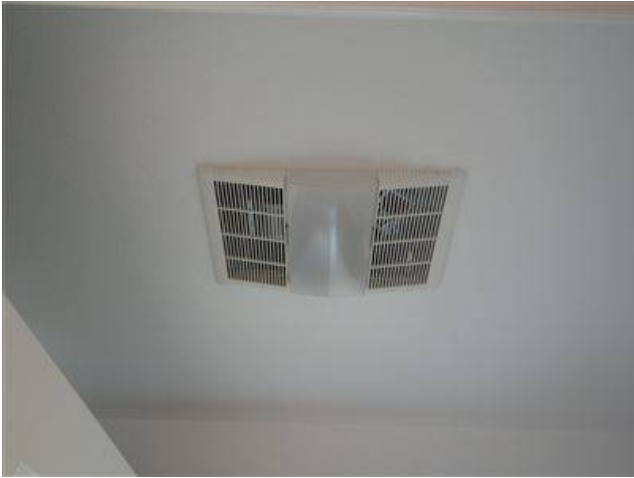
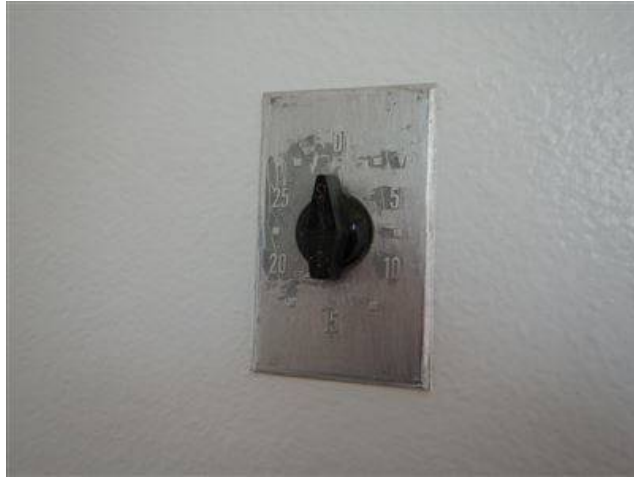
Photo 21-1

21) **i** The exhaust fan at location(s) #A was not operable. Only the fan's heater operated when the knob was turned. No switch found to operate the exhaust fan only. Recommend consulting with the property owner about this.

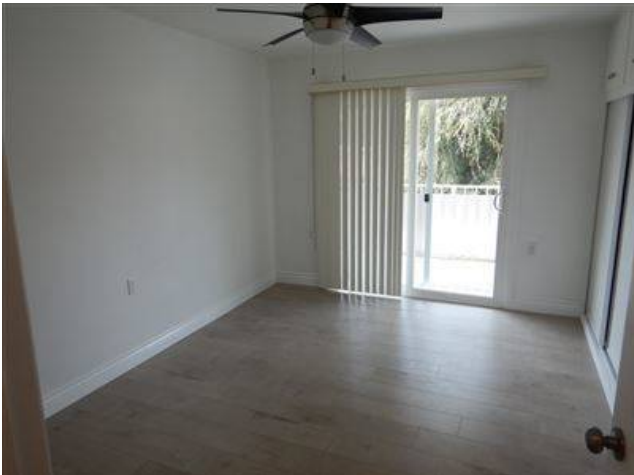
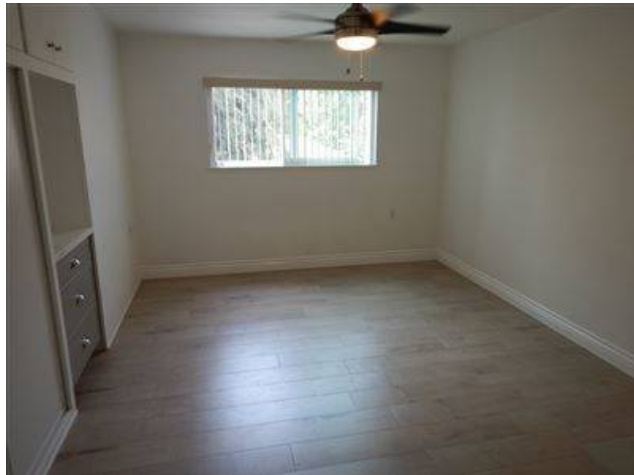
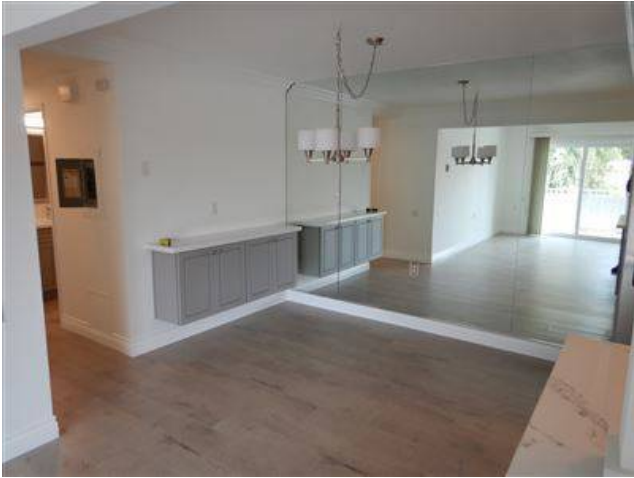
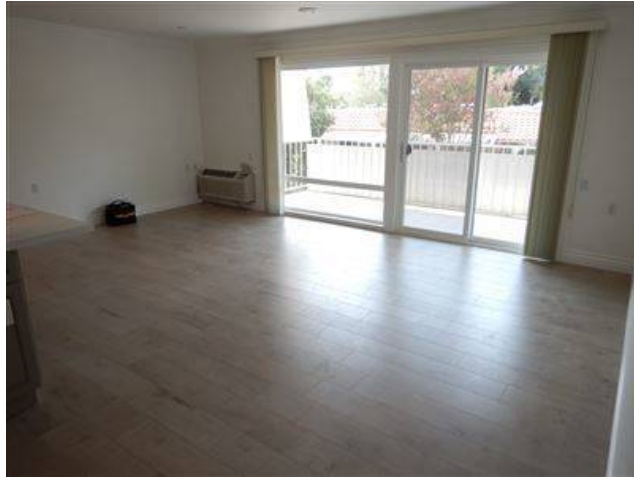
Photo 22-1

The interior rooms appeared to be in overall good condition.
